Ordinance No. 2018-016.

Window Repair or Replace:

Guidelines for Restoration of historic windows:

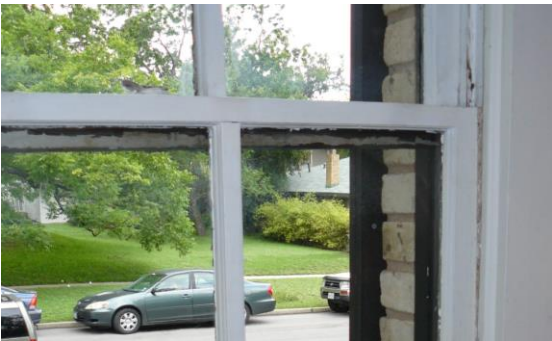
Meeting Rails not aligning

- Paint, glaze, glass, missing or broken
- Meeting rails not aligning;
- Cords broken or hardware missing;
- Sill or frame rotted;
- Partially rotted rails and stiles which require patching.

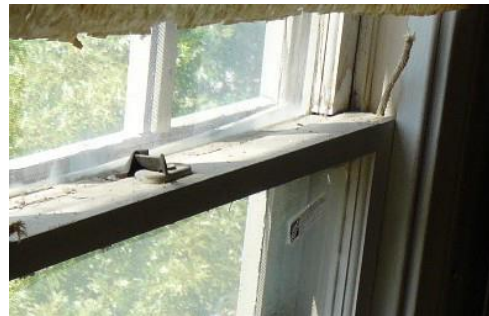
Cords broken or missing hardware

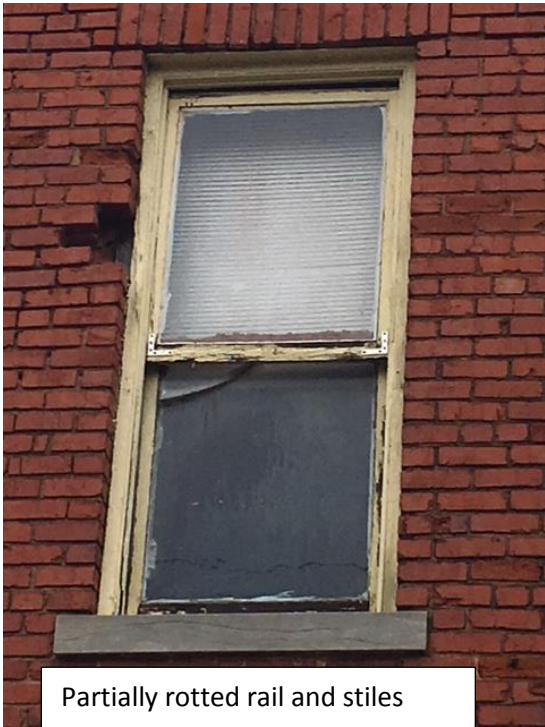
Missing glazing and paint, minor frame rot

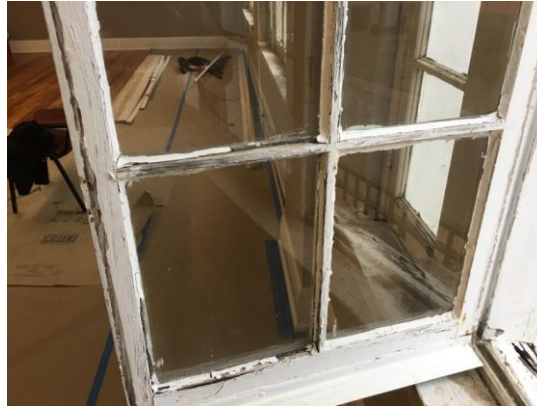
Partially rotted rail and stiles

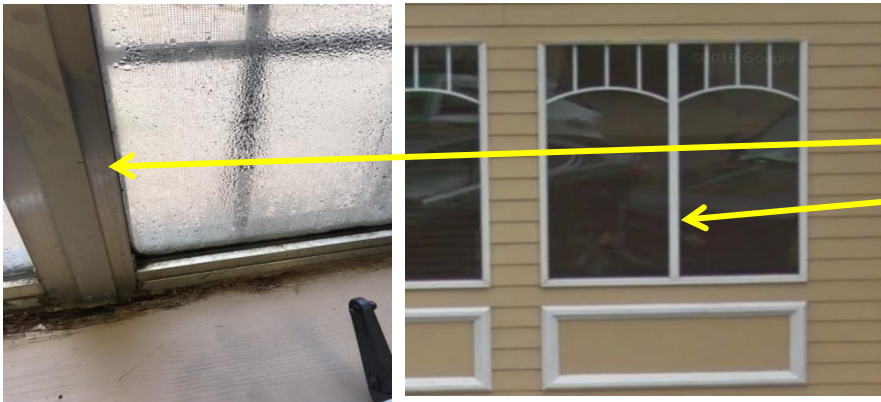
1. Aluminum anodized
2. vinyl windows

<p>Vinyl product changes the Material</p>	<p>Sash components do not feature traditional dimensions</p>	<p>Window trim and sill detail not consistent with original</p>
<p>Window is not recessed within frame</p>	<p>Coating that are heavily tinted or reflective</p>	<p>Meeting rails thicker than original</p>
<p>Track insert alters profile</p>	<p>Retrofitting with different size window than opening.</p>	<p>Aluminum anodized</p>

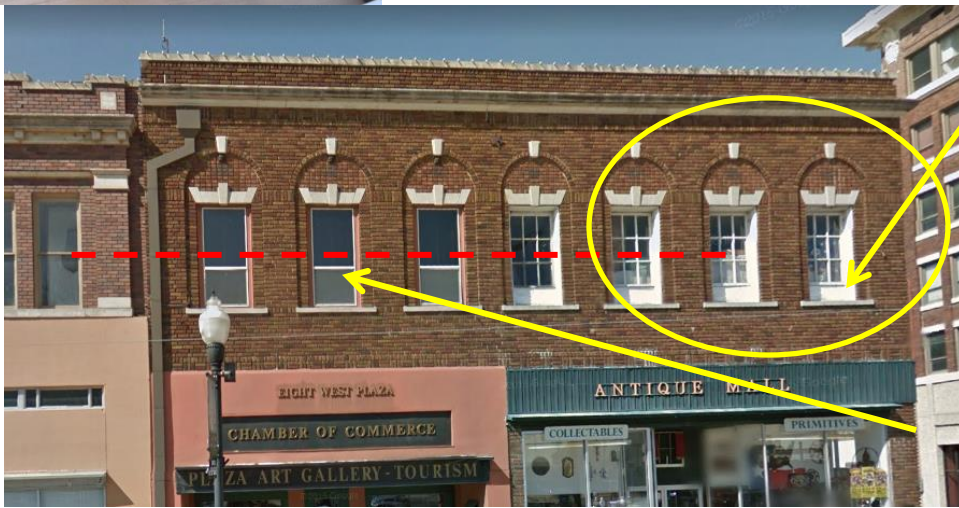
3. Retrofitted windows. New window dimensions smaller than original openings.
- Uneven symmetry: meeting rails should mimic original features and symmetry of downtown building.

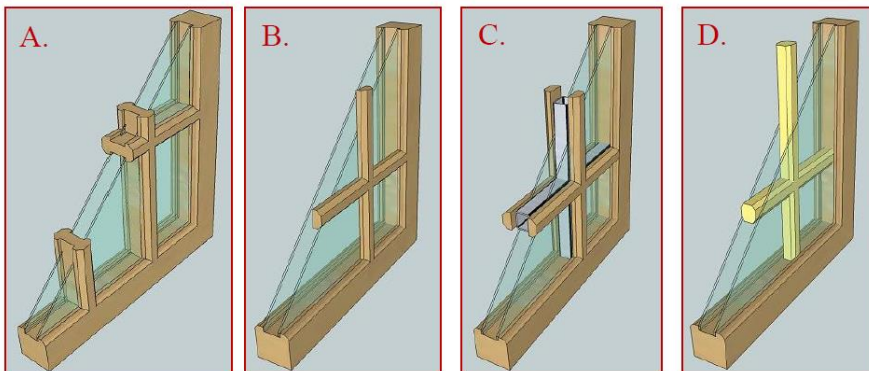
- A. True Divided Lite with Double Glazing
- B. Simulated Divided Lite
- C. Simulated Divided Lite with Spacer
- D. Grilles Between Glass

D. Is not appropriate for the district

Glass size and divisions: Historic windows were constructed with single panes of glass held together with wood pieces and glazing compound. These wood pieces formed a grid called a muntin. This construction method (several small pieces of glass held together with muntins) is called a true divided-lite. This is the best option for replacement because it will give the same appearance as the historic window.
